OP-05

***Oxidation durability of the Mo/Si multilayer
with an oxide capping layer***

Takashi Yamaguchi, Noriaki Kandaka, Atsushi
Yamazaki, Tsuneyuki Hagiwara, Tetsuya
Oshino and Katsuhiko Murakami

2012 International Symposium on Extreme Ultraviolet Lithography

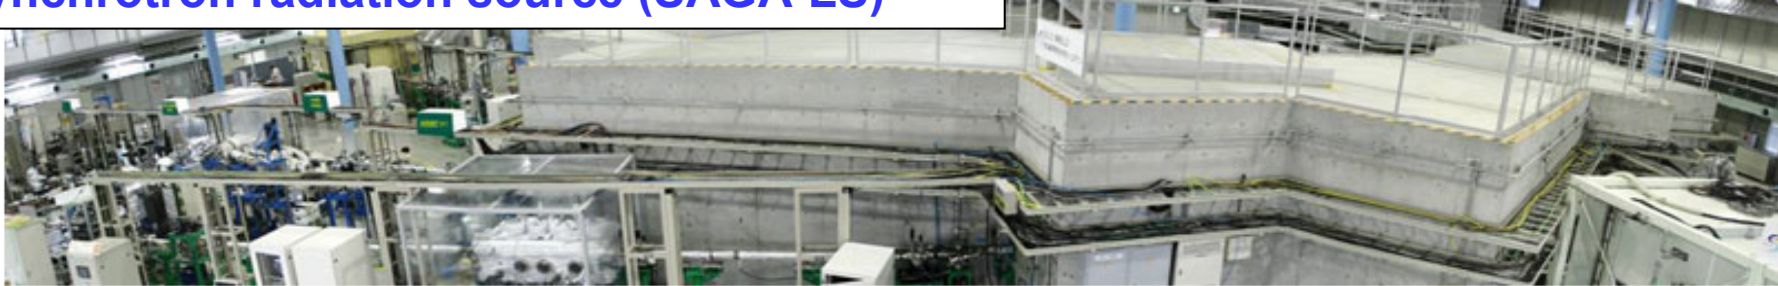
Synchrotron radiation source (SAGA-LS)

Energy: 1.4GeV, Beam current: 100~300mA, Circumference: 75.6m
